JOB PROGRESS: CLEANING, FAILED MEMBRANE REMOVAL, & WATERPROOFING FOR ELEVATORS 1 & 2

JOB # 200107

**RECIPIENT:
STORAGE STAR**

**PROVIDER:
PYTT SERVICE LLC**

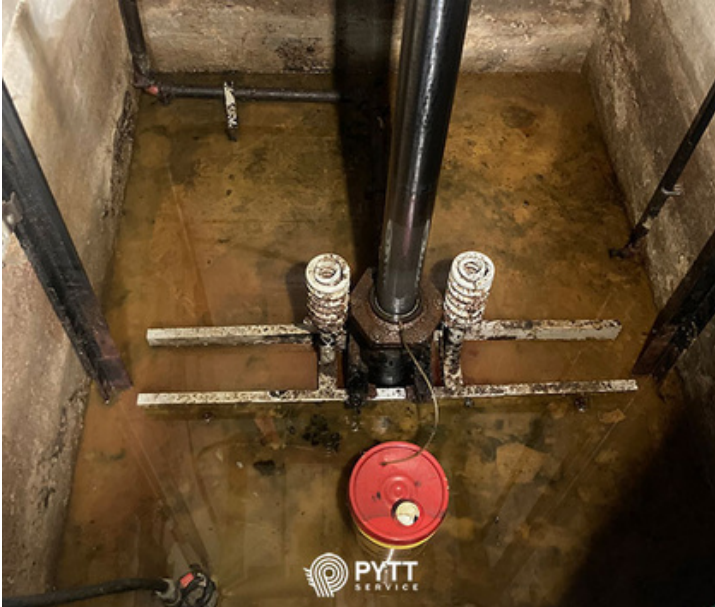
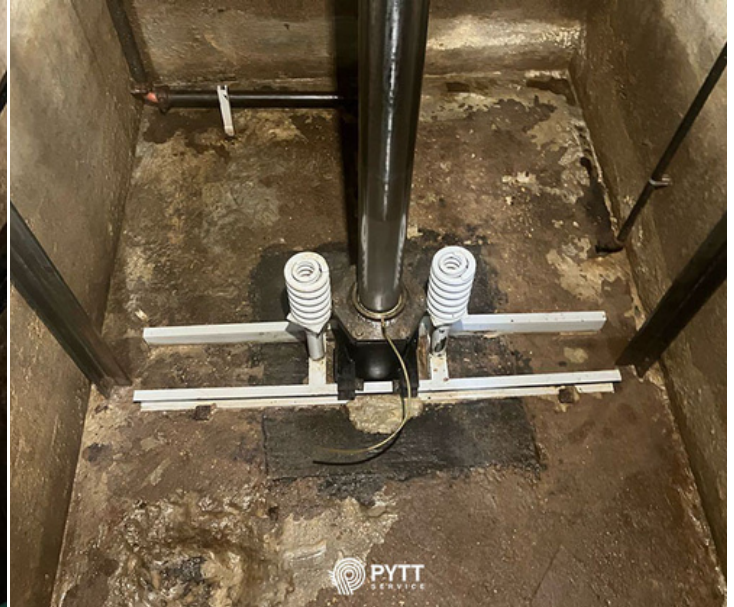
Arrived on site to discover the elevator pit had flooded since our initial inspection. This required an oily water pump-out prior to our pressure washing, de-greasing, and water intrusion inspection.

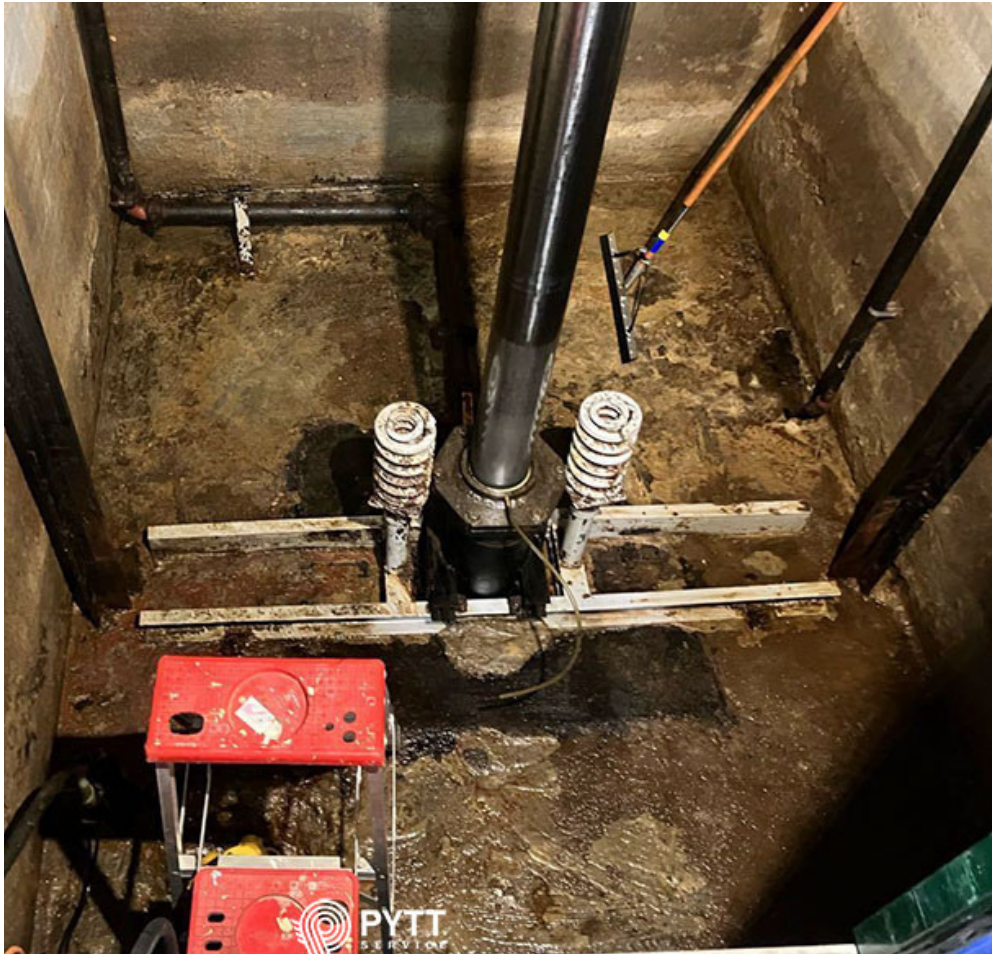
Initial water pump-out

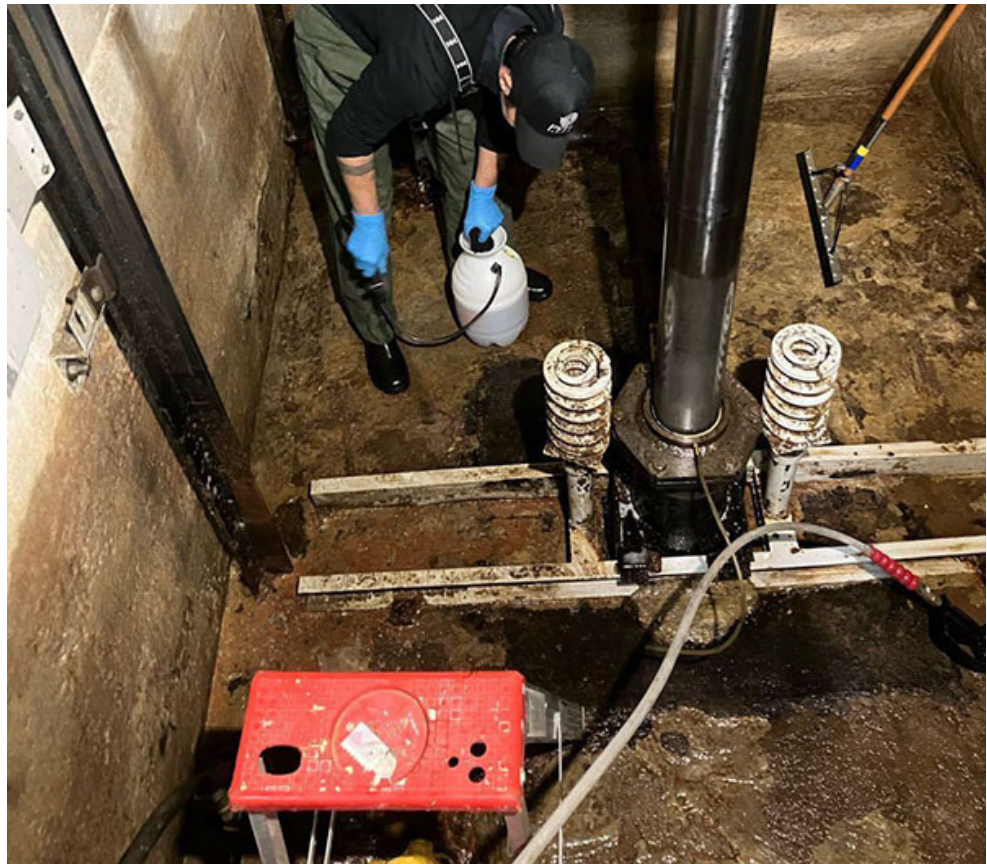
De-greaser application

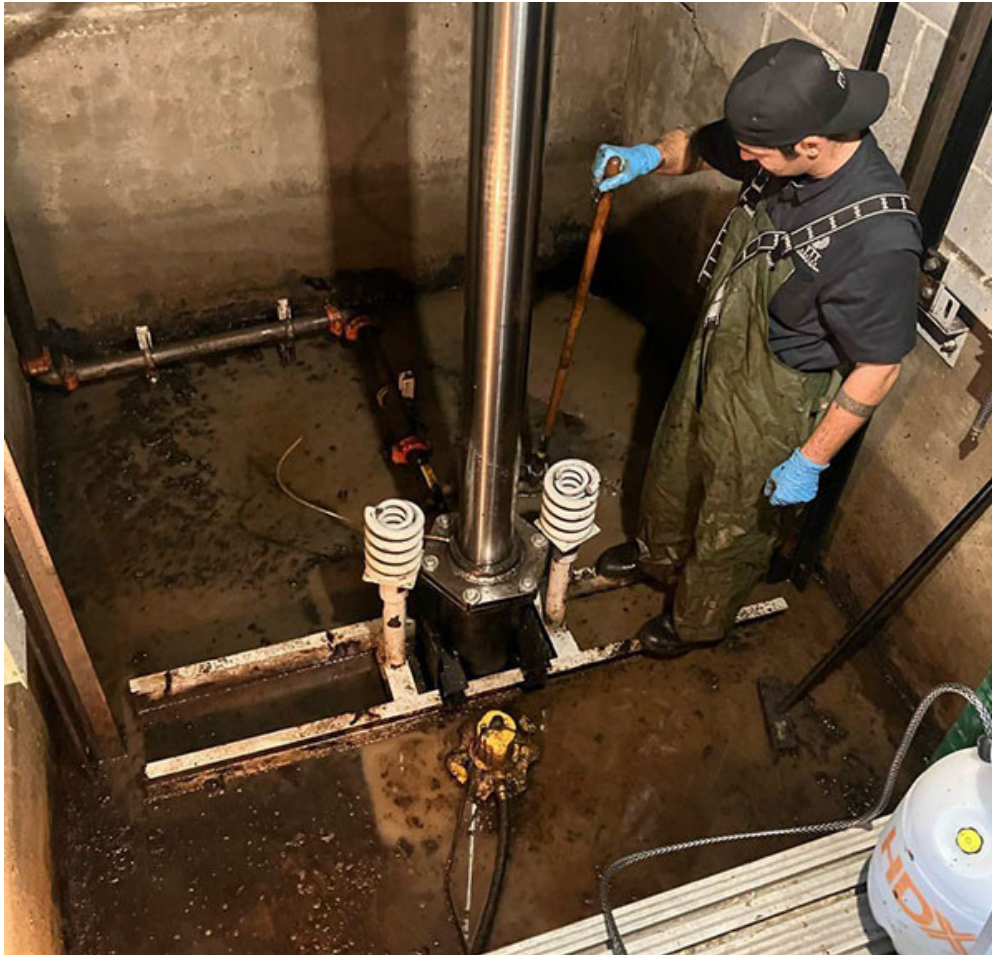
Scrubbed &
Pressure
Washed

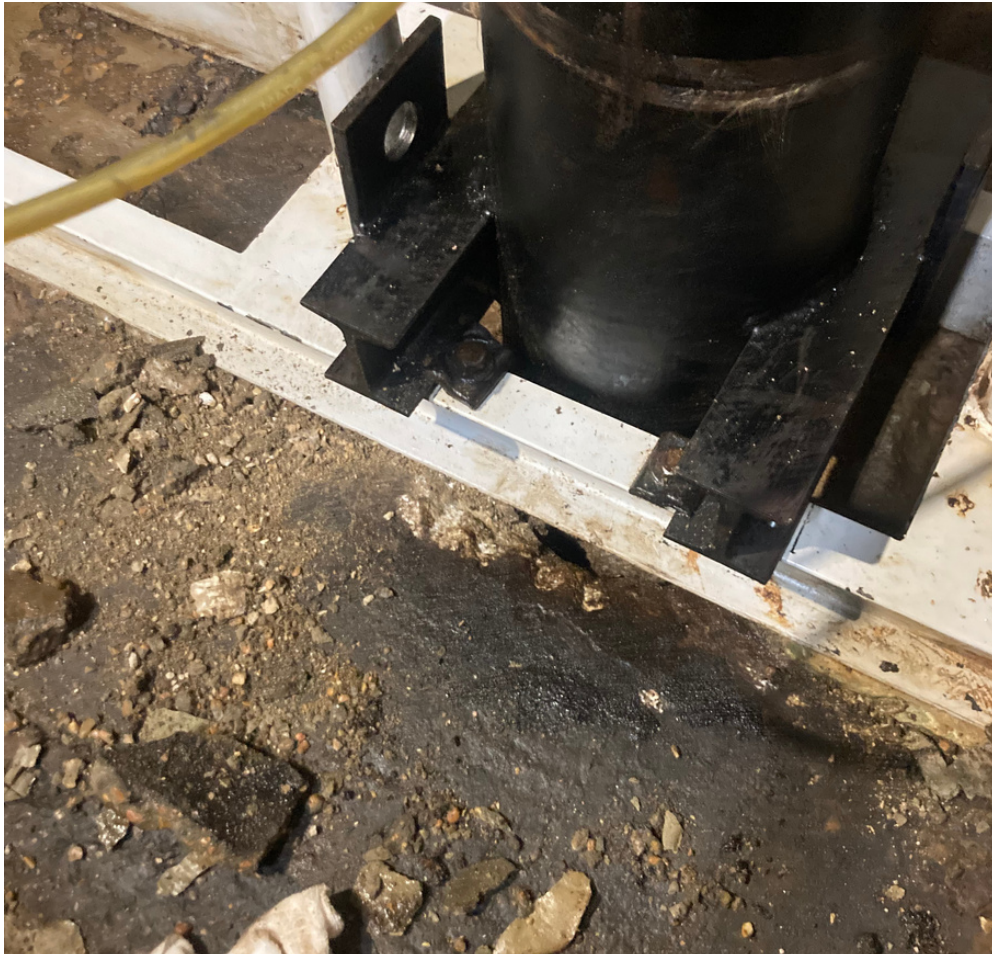
Jack cap removal

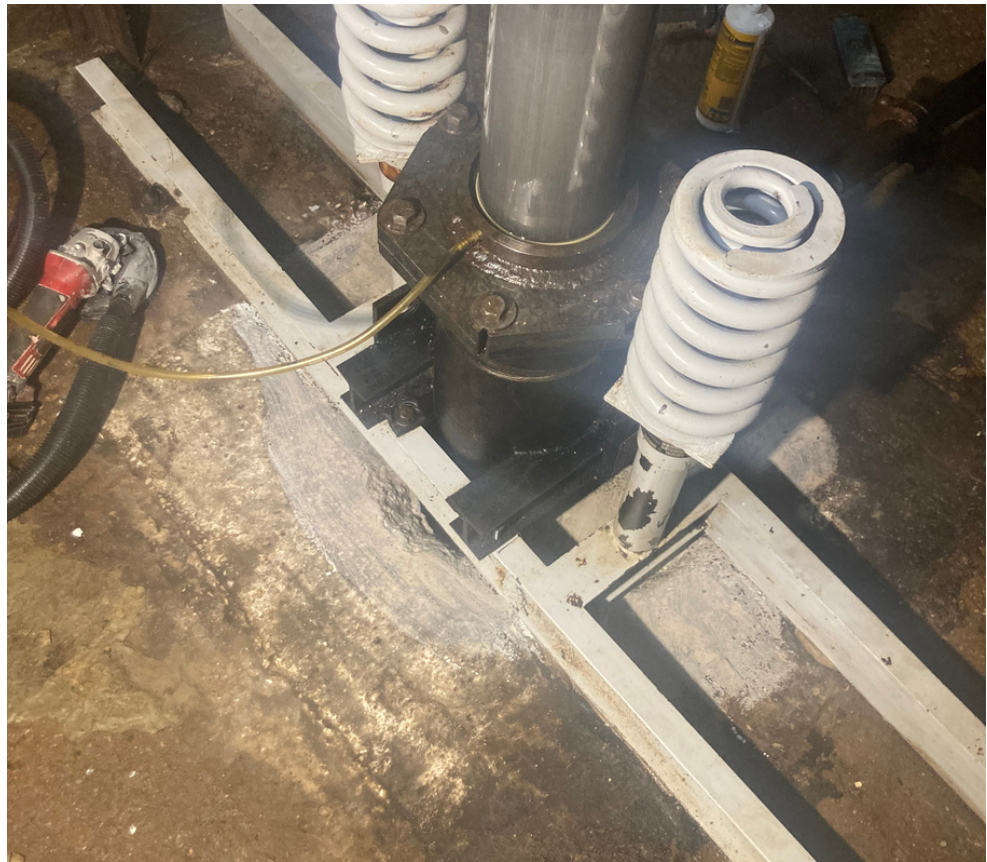
Initial jack cap sealing

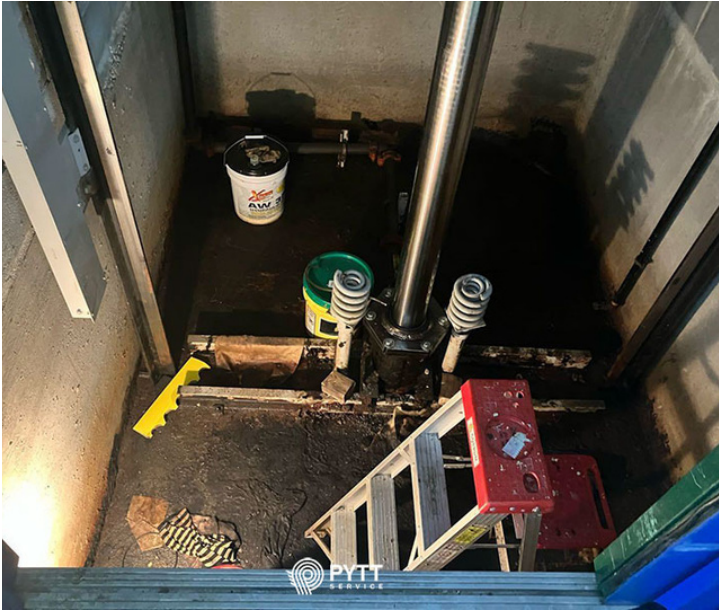
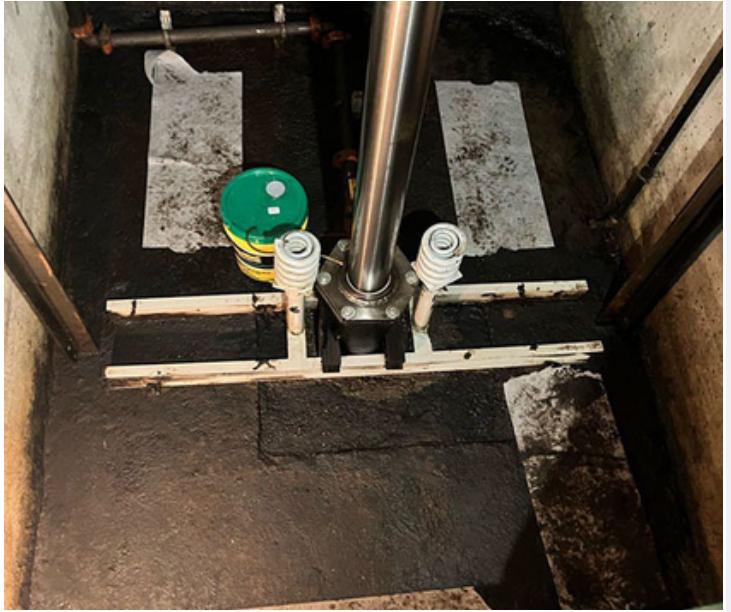
Cleaned up the elevator pit, removing all debris and oil buckets, and pressure washing.

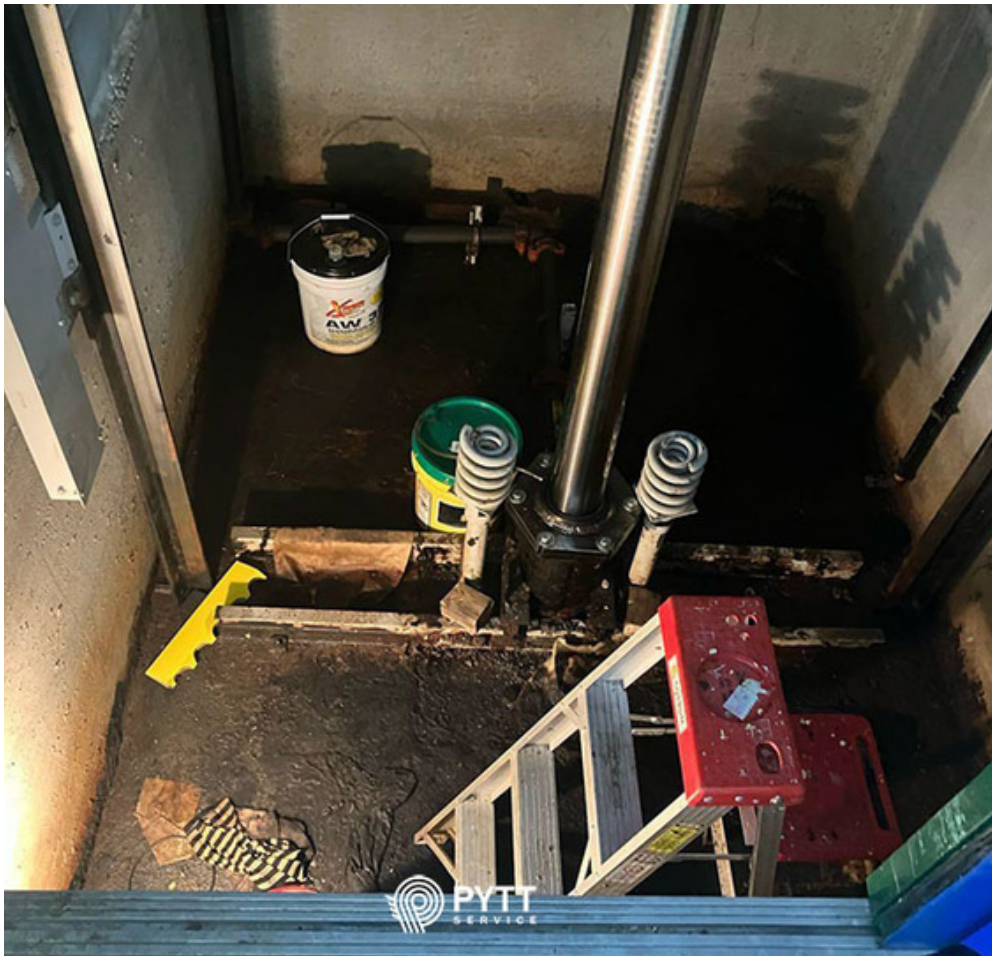
Thick layer of oil & debris, buckets full of oil in pit

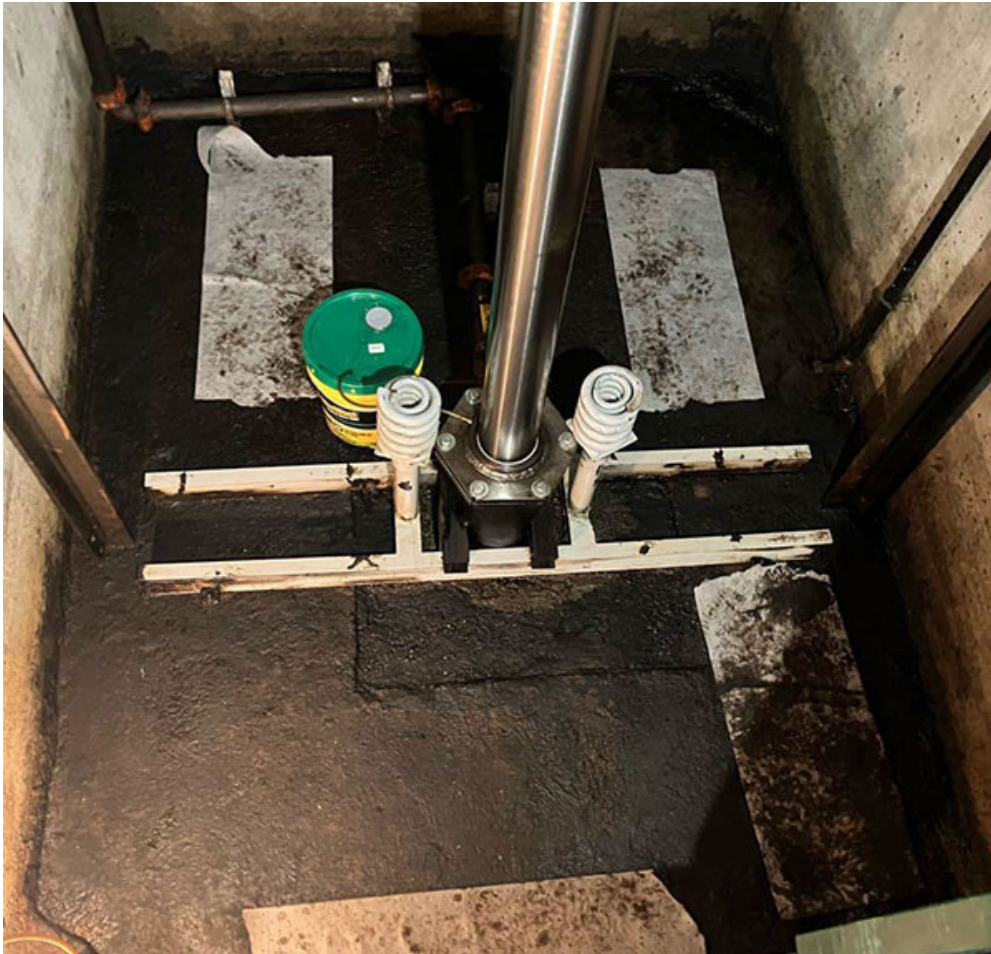
Tar revealed at the bottom of the pressure washed pit

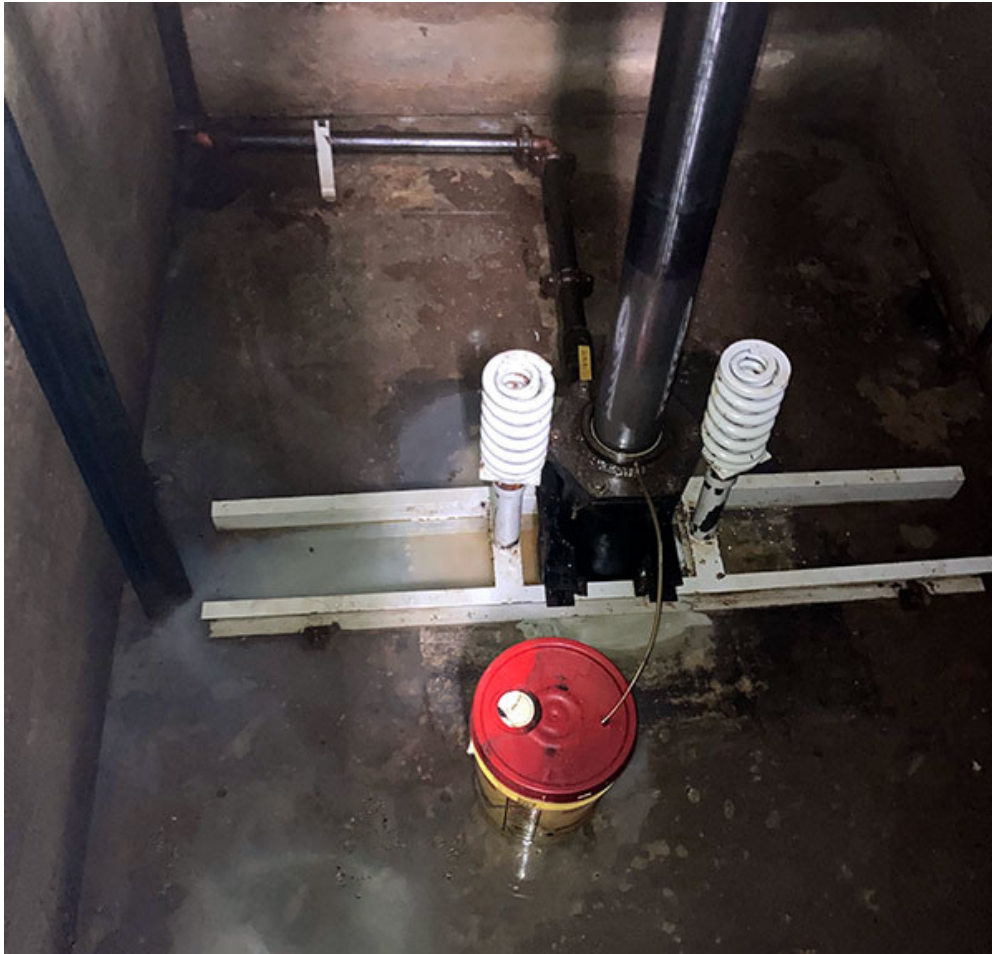
After rain test -
approx. 2 inches
of water

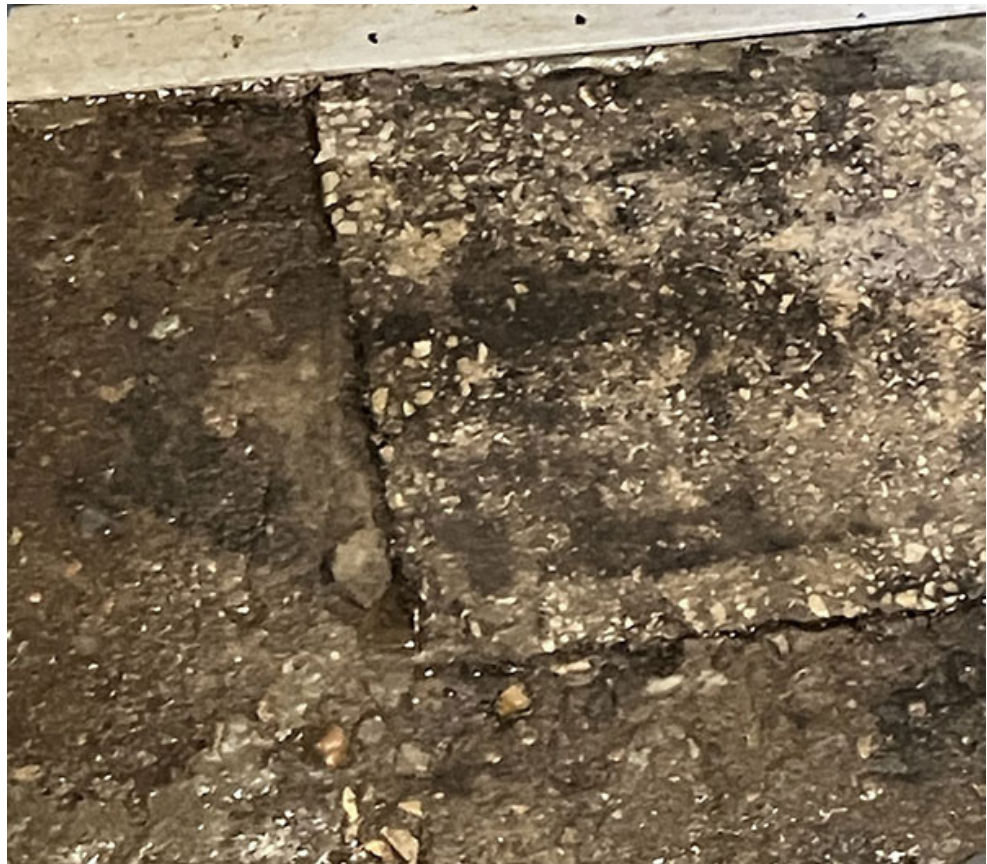
Open jack cap
seam

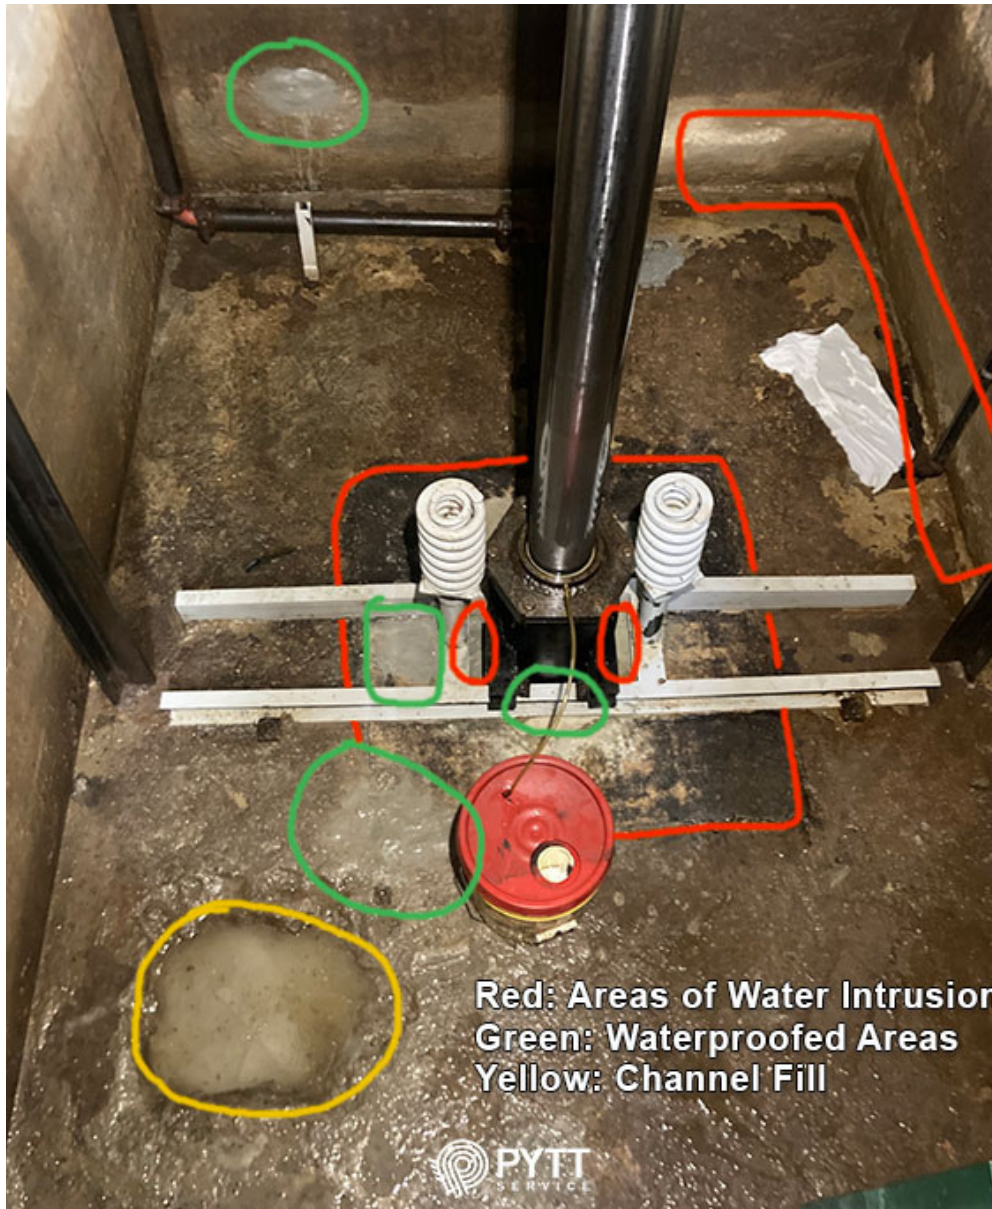
Red: Areas of Water Intrusion
Green: Waterproofed Areas
Yellow: Channel Fill

Rain test revealed several points of water intrusion. Applied waterproofing where possible with the current water pressure level.

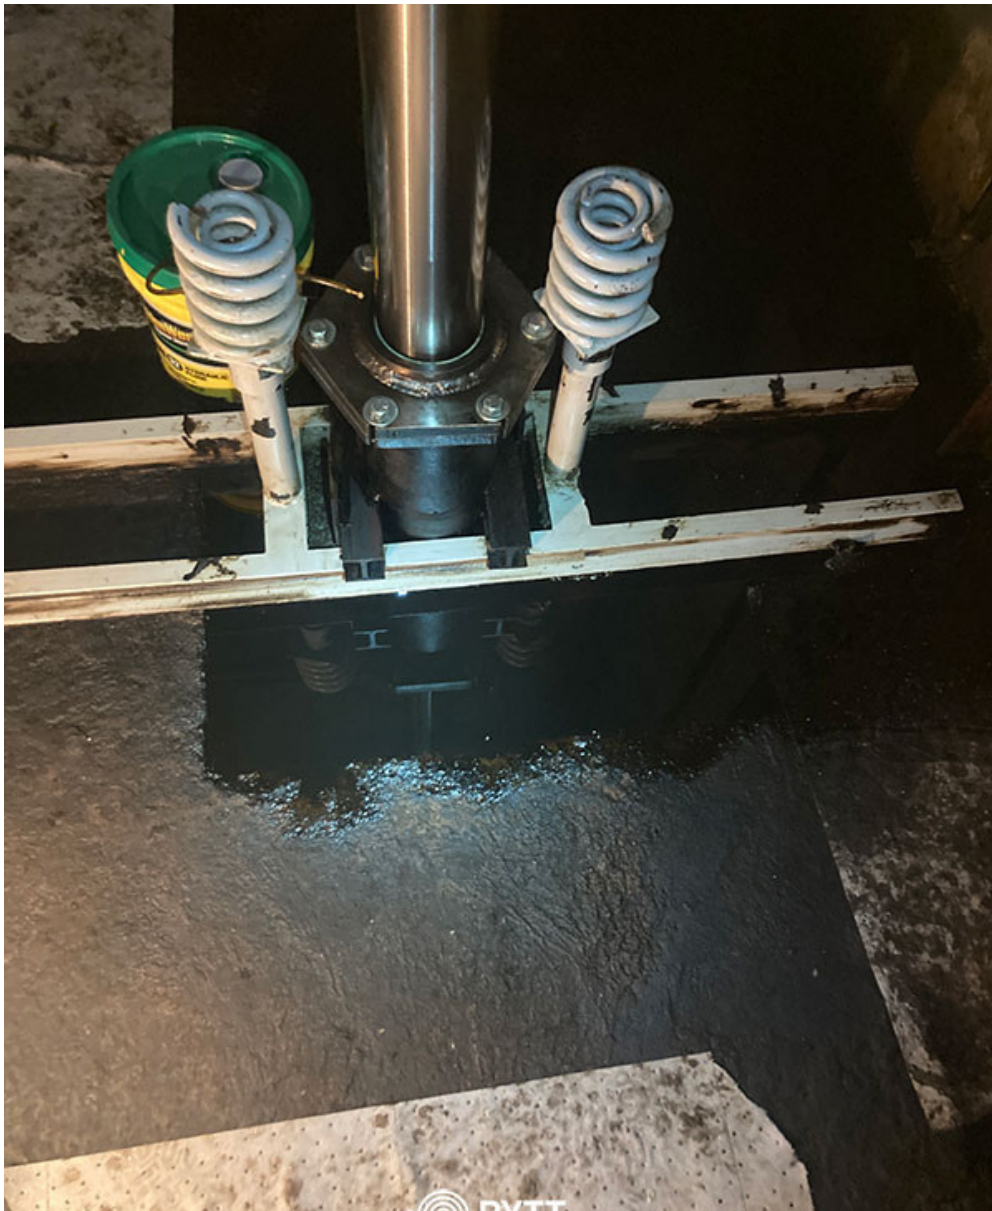
Oil was discovered in the bottom of this pit. The current plan is to handle this when the groundwater recedes.

Rising water levels revealed oil from the jack casing

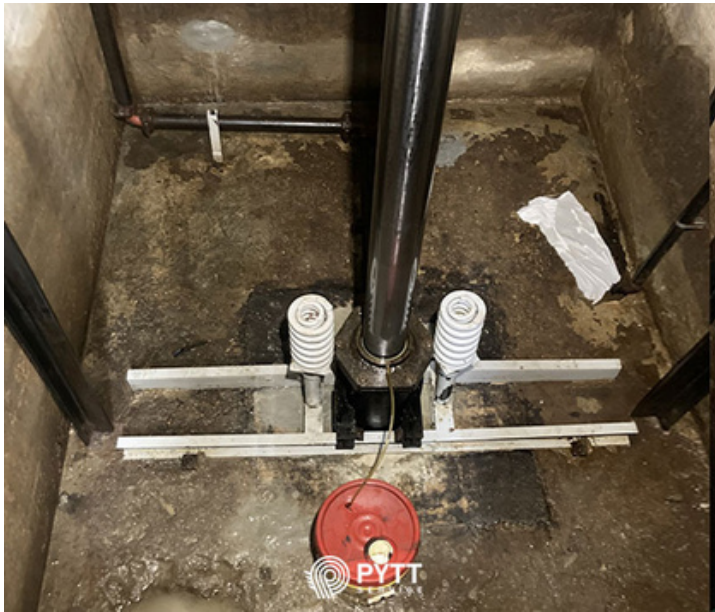
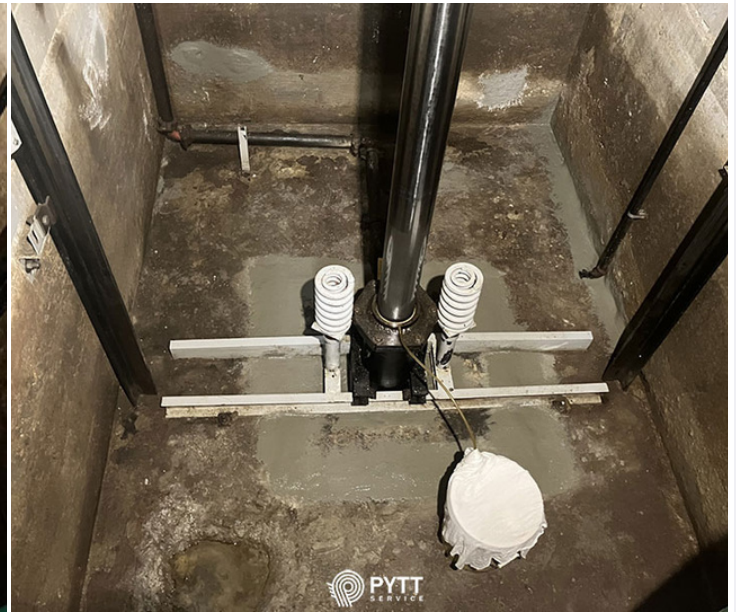
Chiseled, drained, and applied first and second layers of waterproofing to all active leaks. This includes all seams around the jack cap, right wall seam, and voids along the back wall and under the car door.

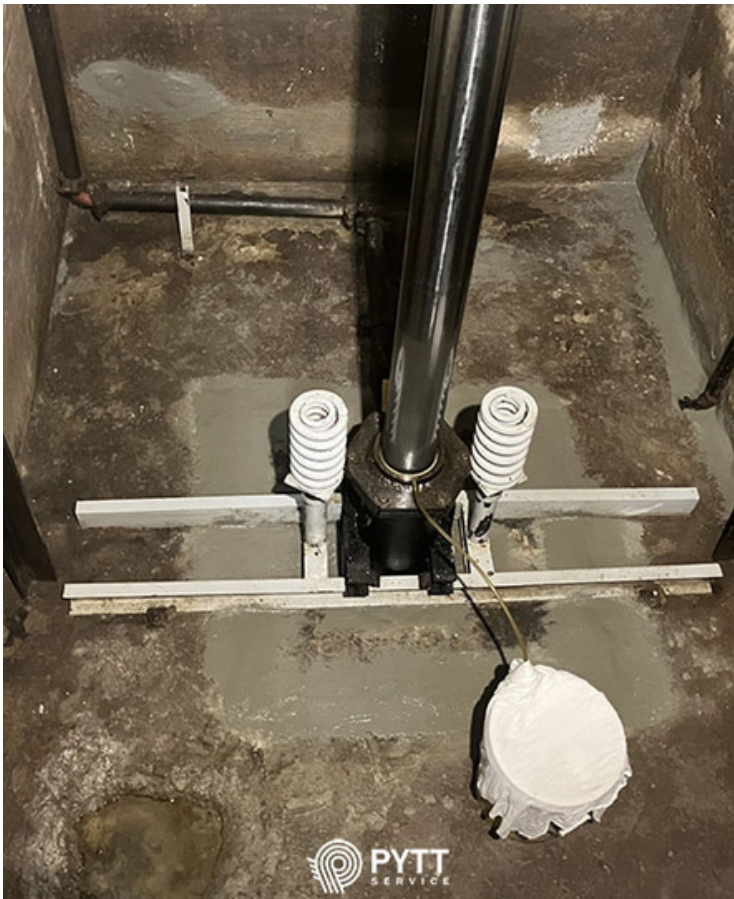
Overall application

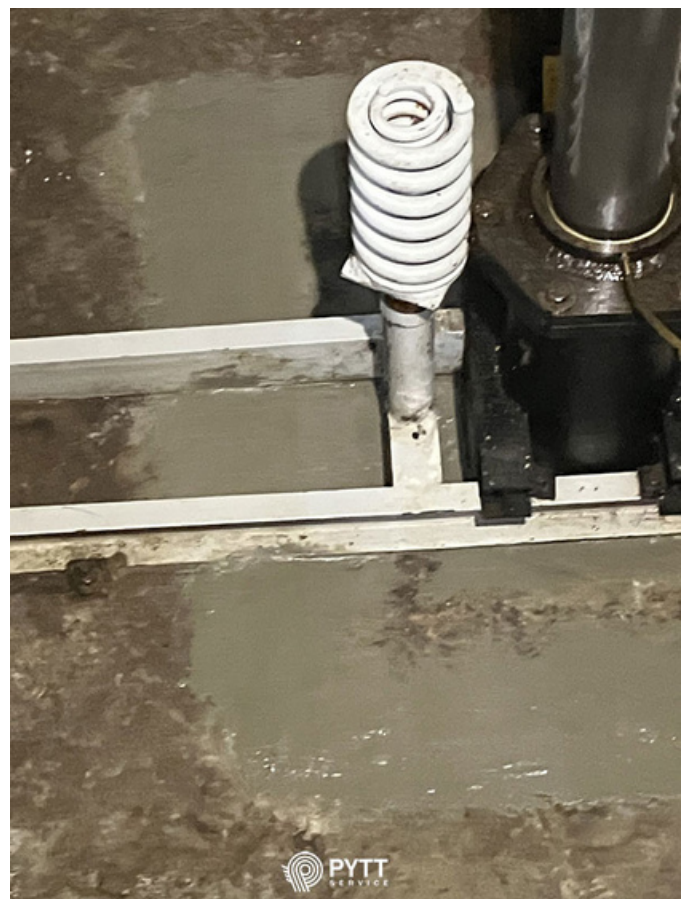
Left side of jack cap

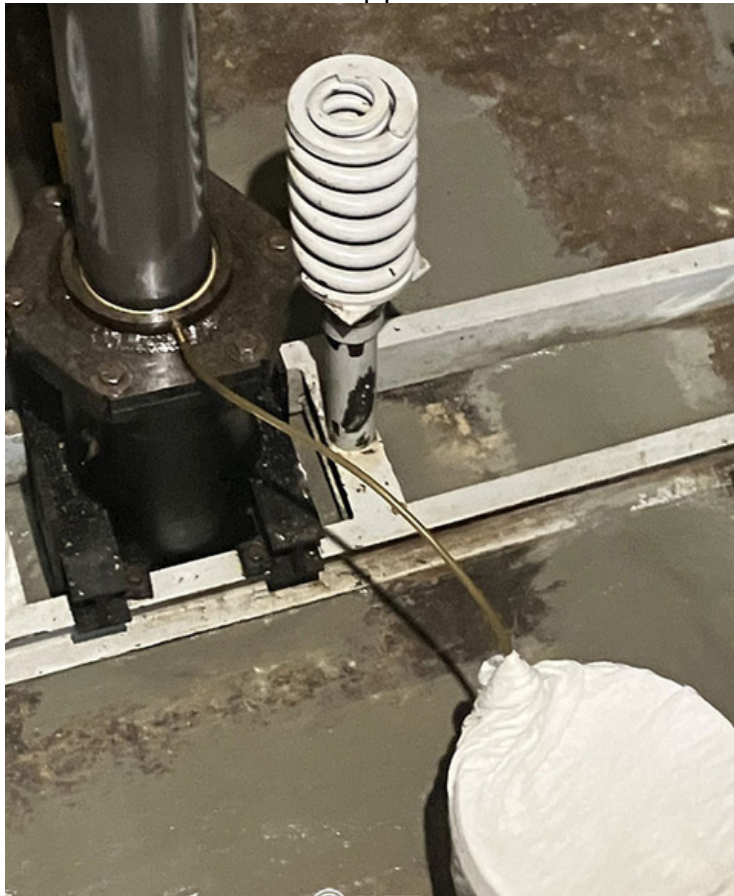
Right side of jack cap

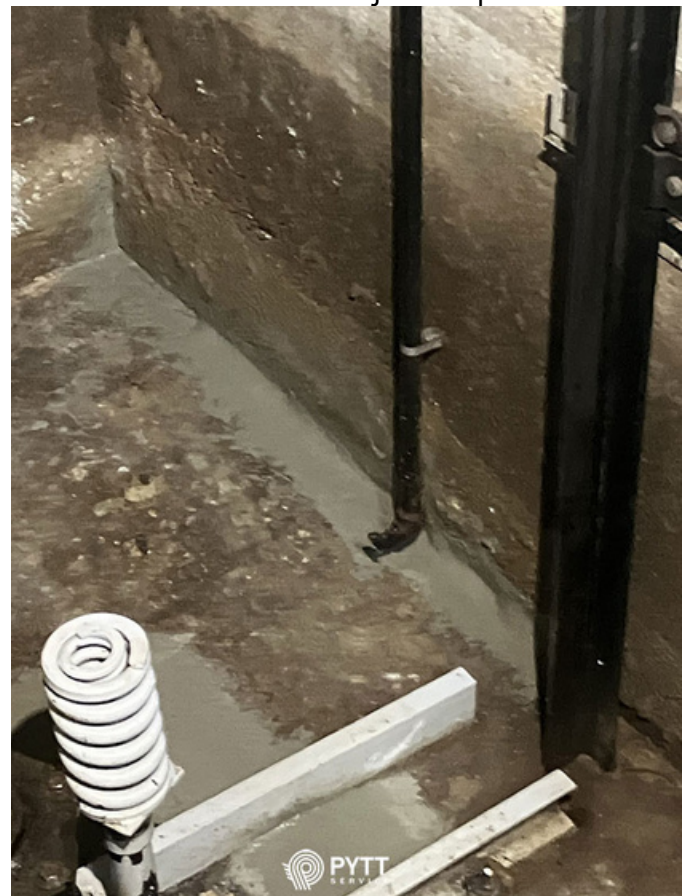
Right wall seam

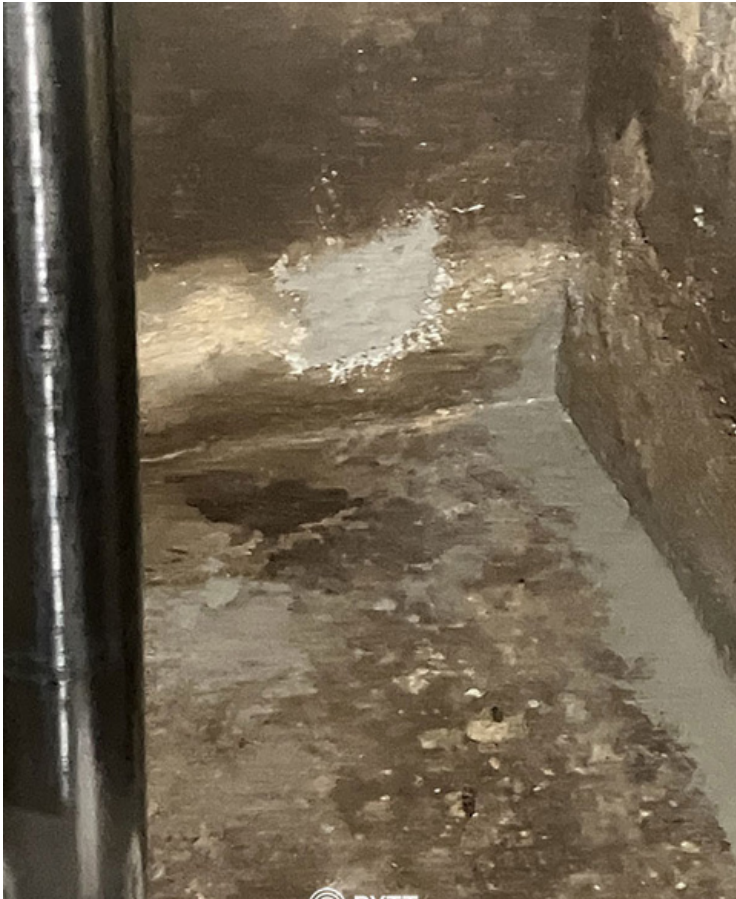
Back wall void, right side

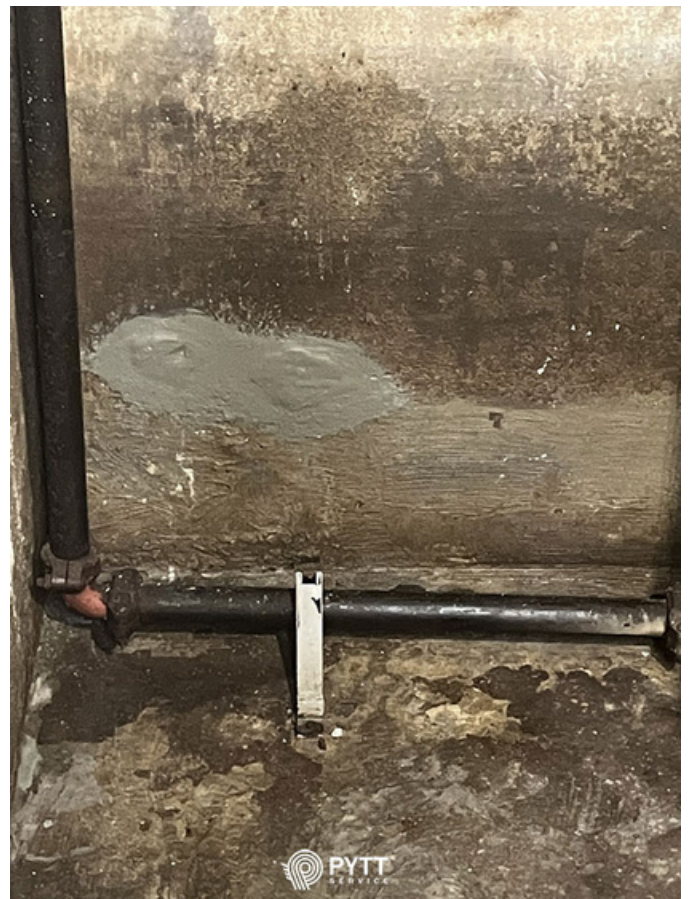
Back wall void, left side

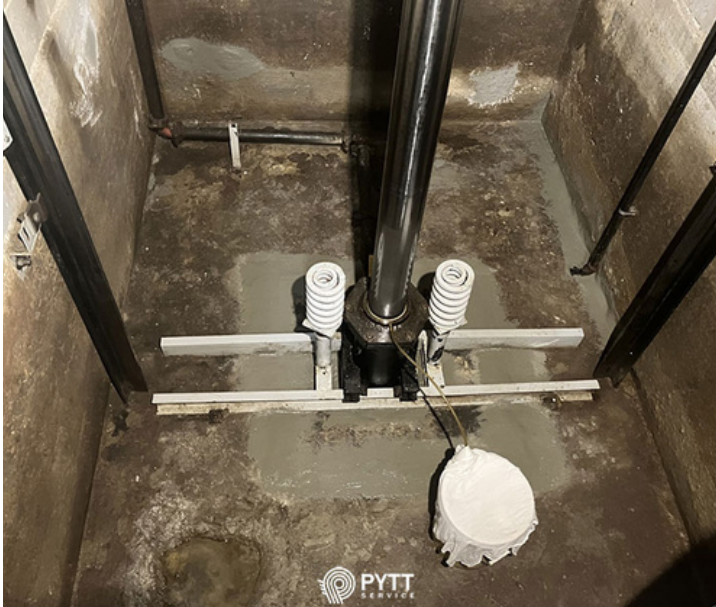
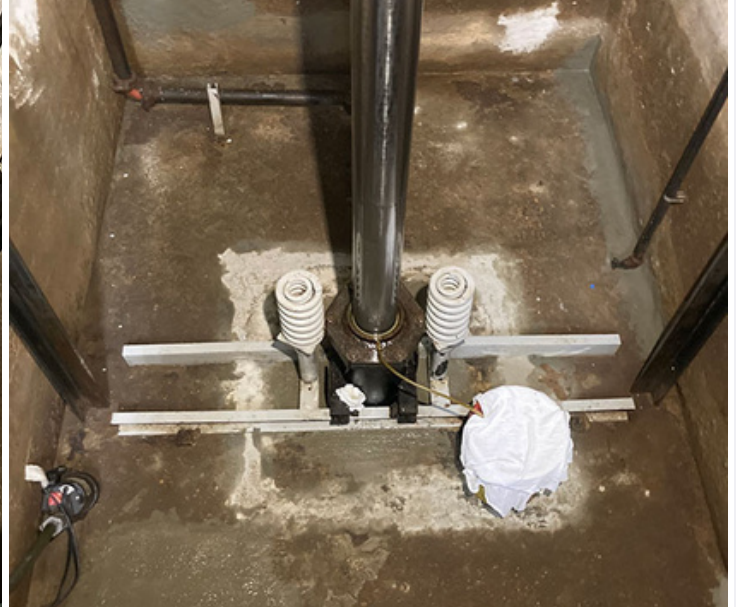
Returned to nearly fully waterproofed elevator pit (98% dry). Filled the open pit channel. Finished chiseling and applying first and second stages of waterproofing to the wall under the car door. Still need to return to apply our third-stage layer of waterproofing to all seams.

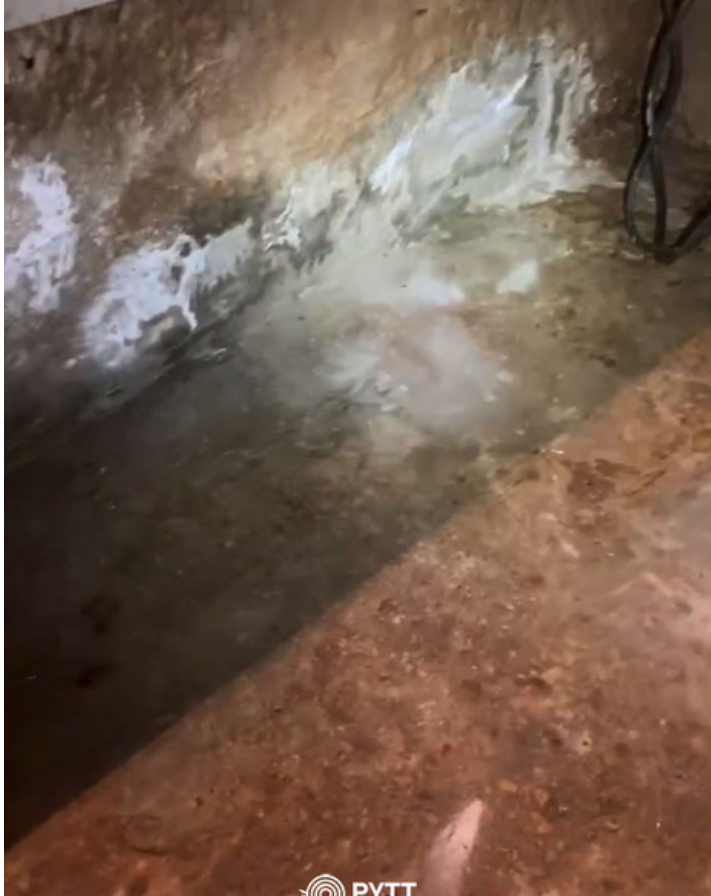
Door-side water intrusion (L)

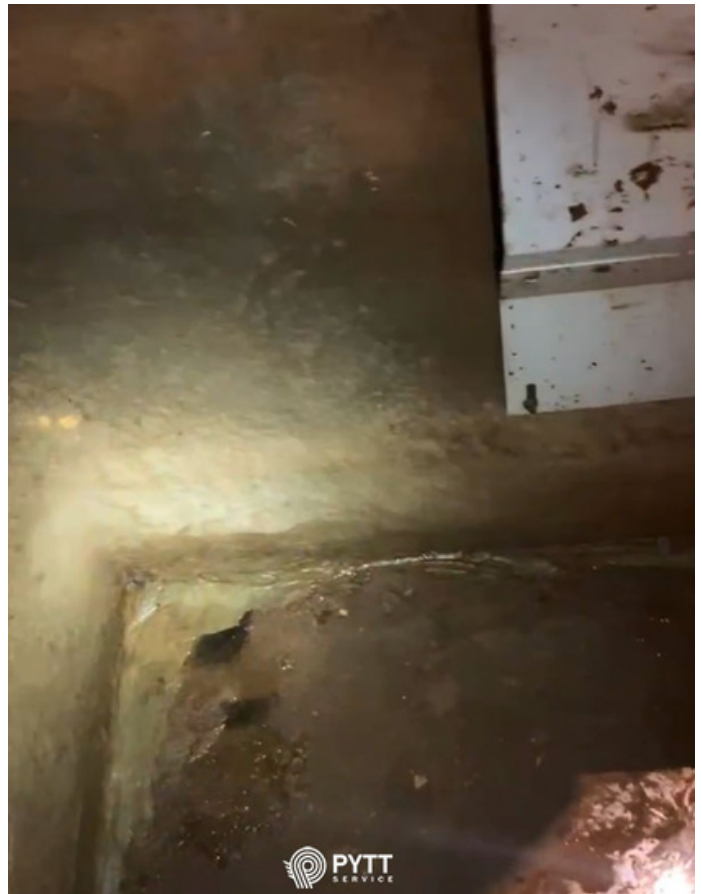
Door-side water intrusion (R)

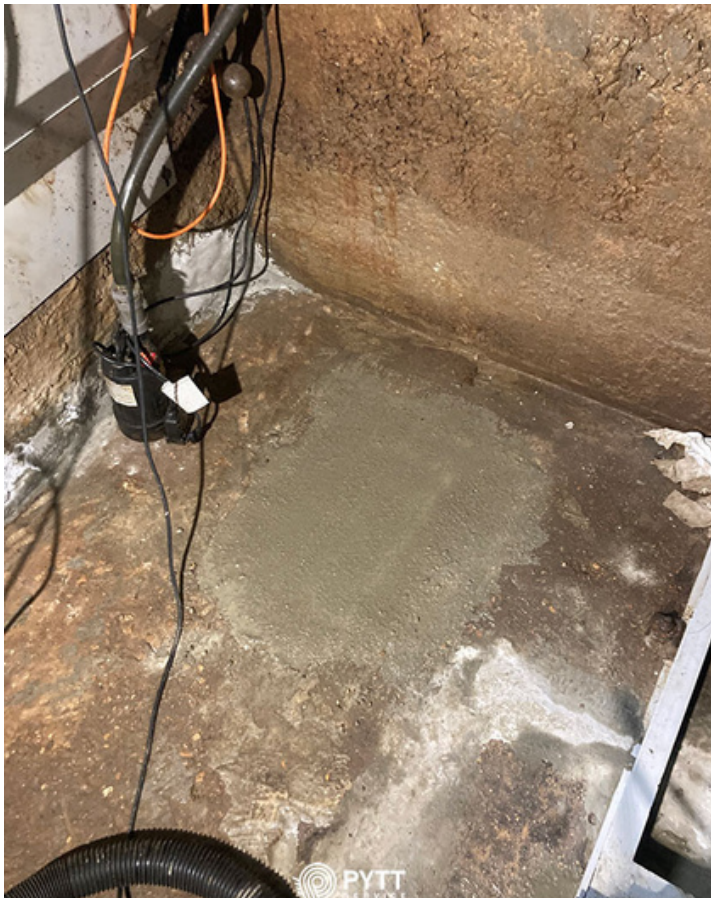
Channel fill

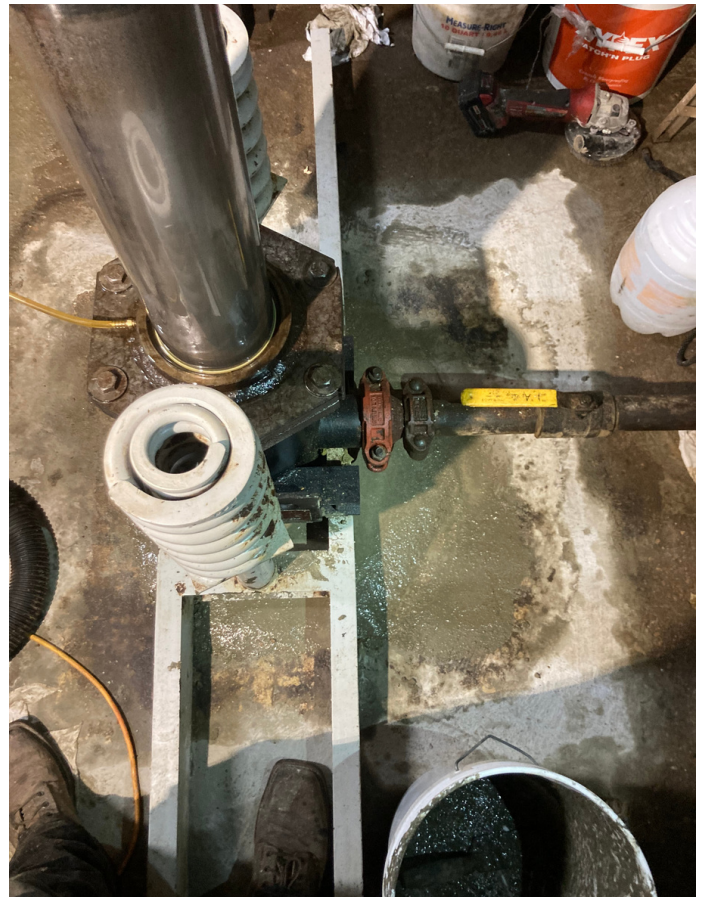
Jack cap waterproofing

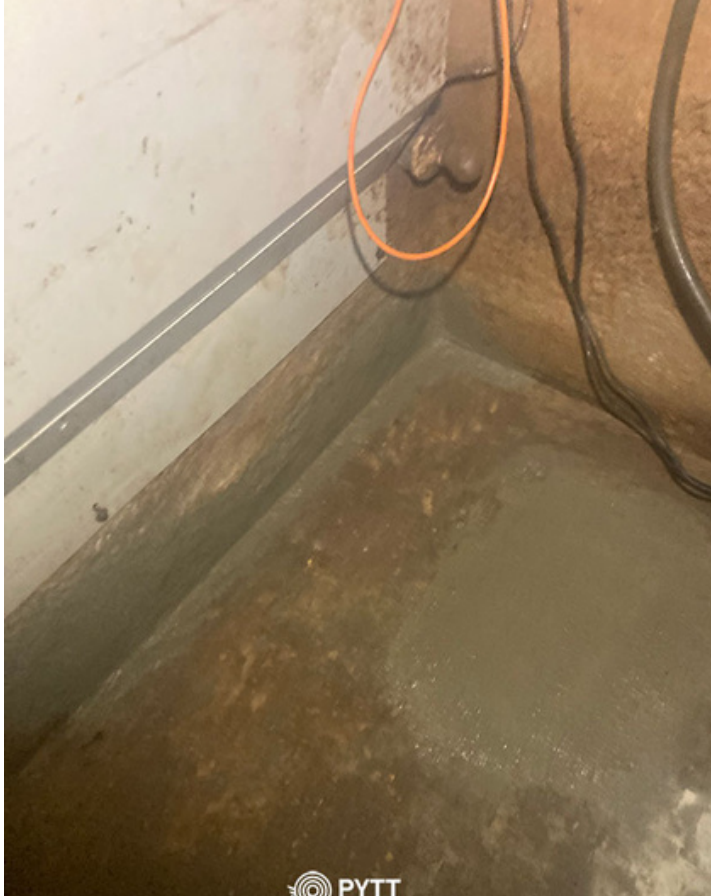
Door-side waterproofing (L)

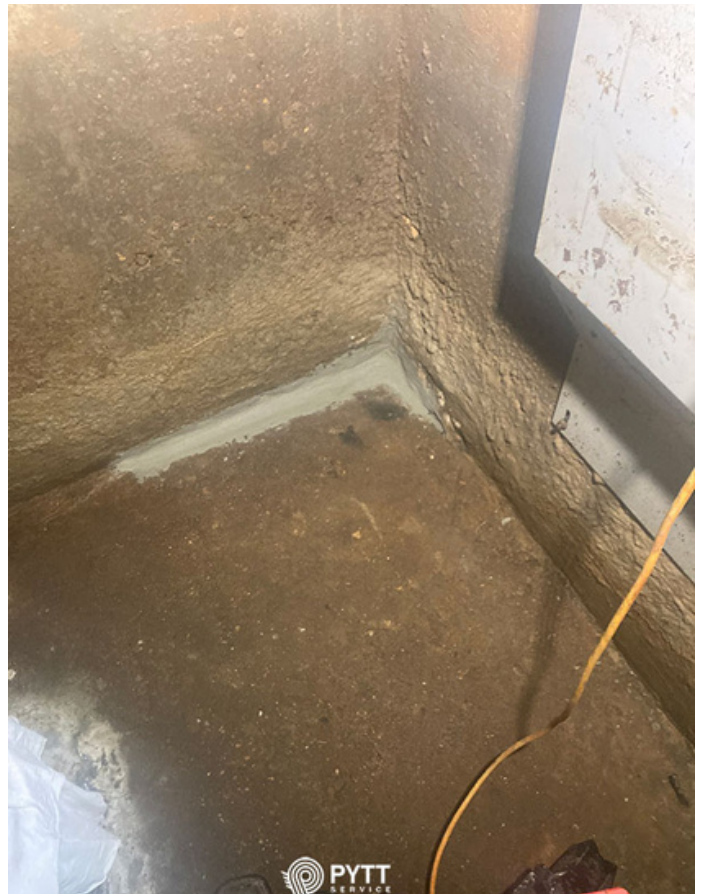
Door-side waterproofing (R)

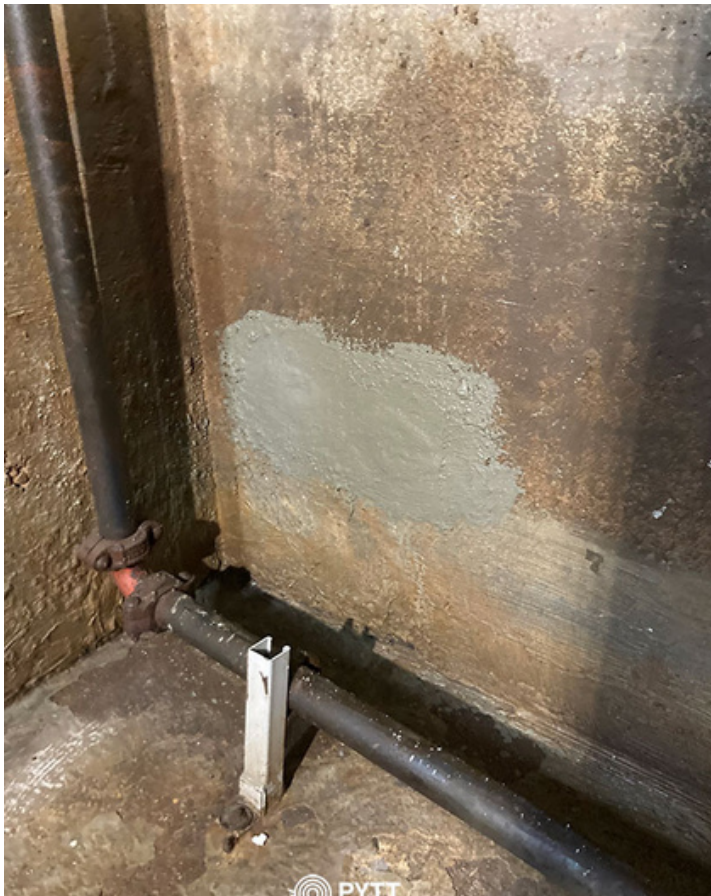
Back wall void waterproofing
