JOB PROGRESS: CLEANING, FAILED MEMBRANE REMOVAL, & WATERPROOFING FOR ELEVATORS 1 & 2

JOB # 200107

**RECIPIENT:
STORAGE STAR**

**PROVIDER:
PYTT SERVICE LLC**

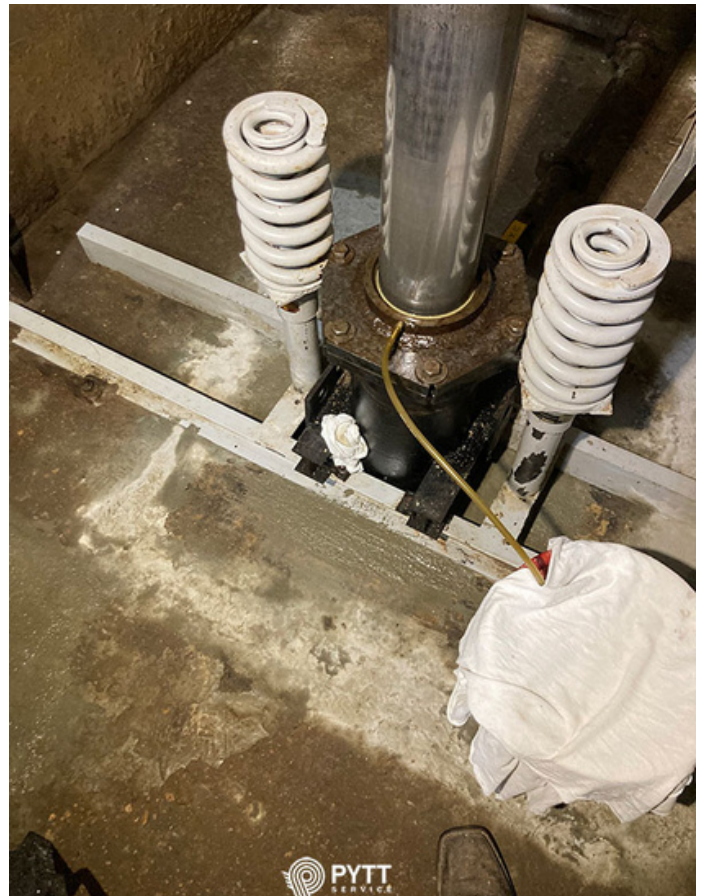
Jack cap waterproofing

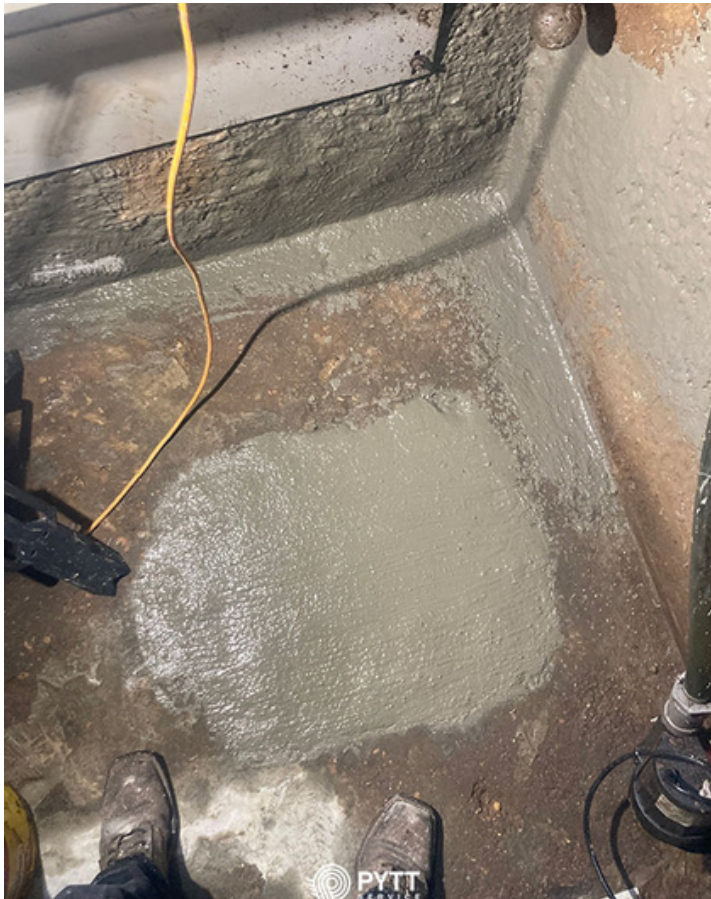
Waterproofing coat over channel fill

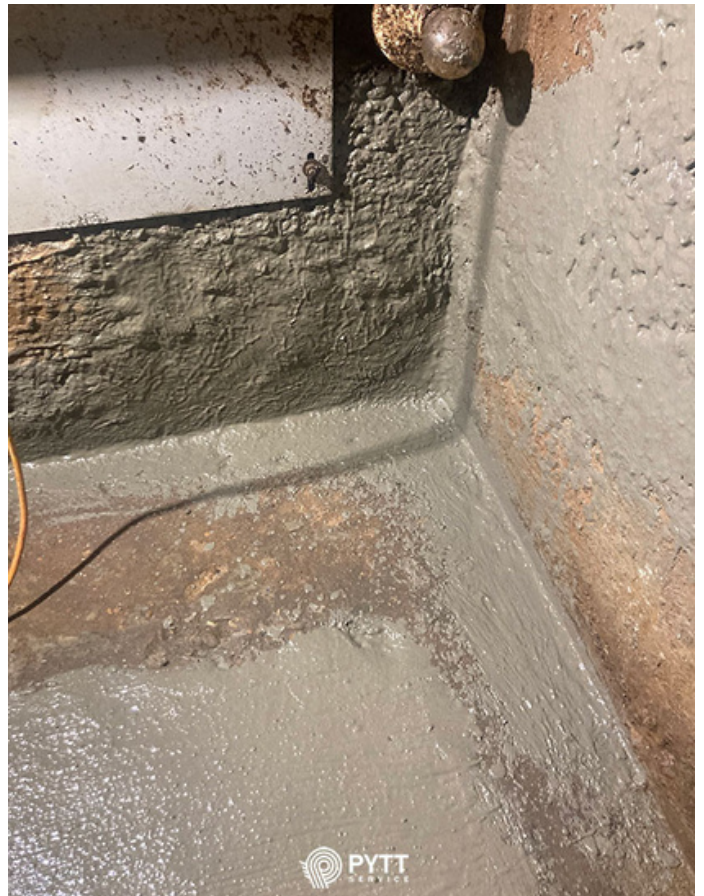
Waterproofing coat over corner

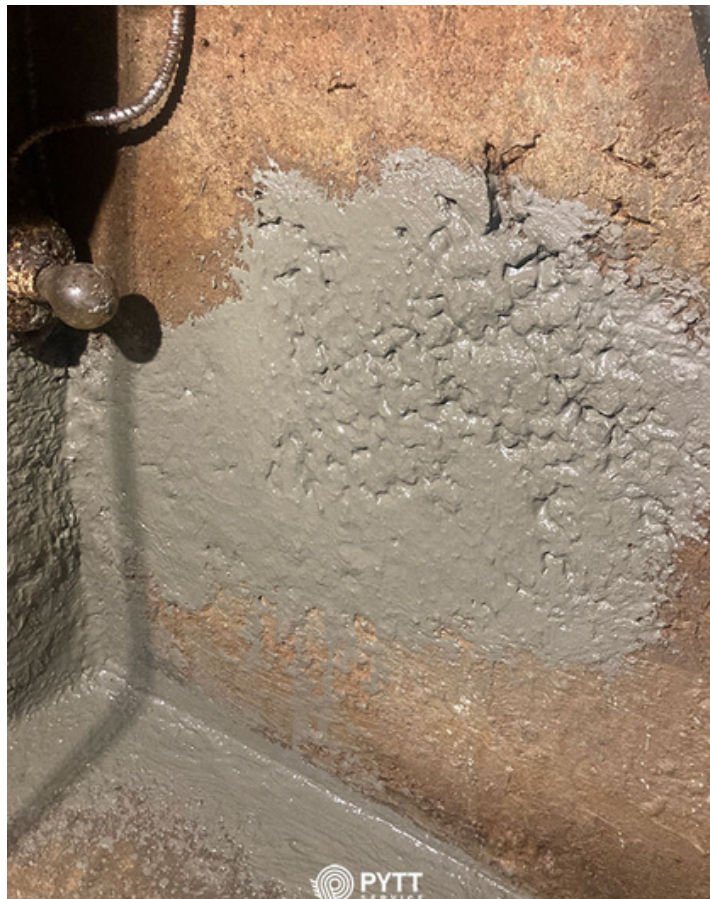
Honeycombed wall waterproofed

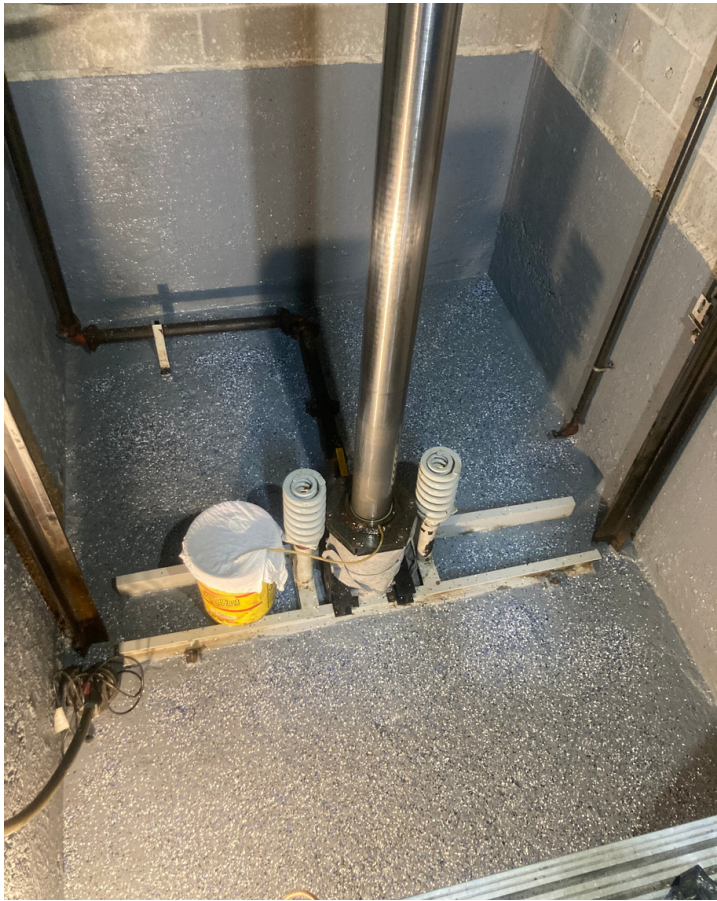
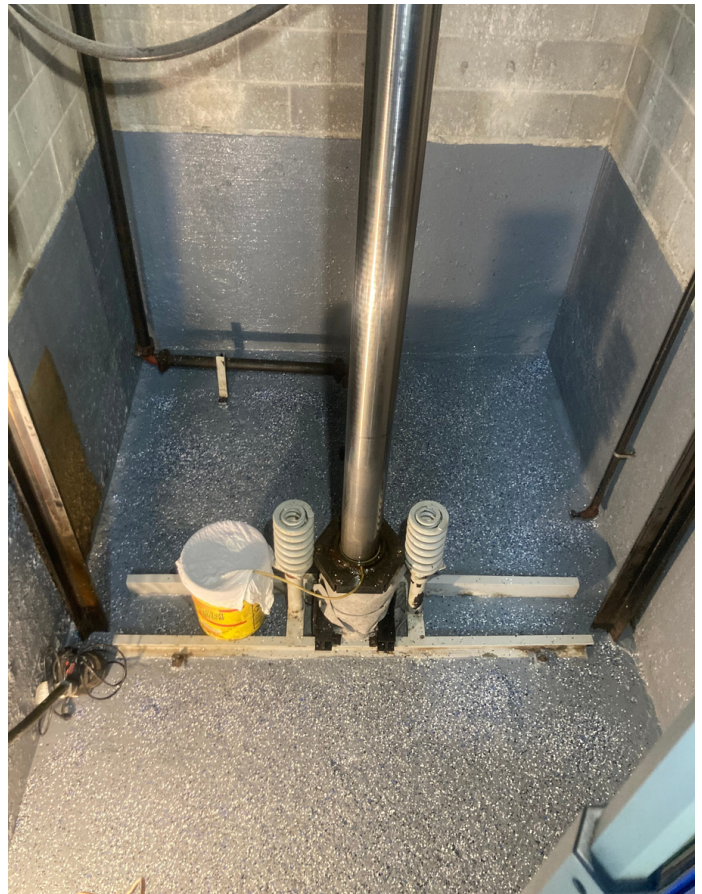
Elevator 2 waterproofed & painted

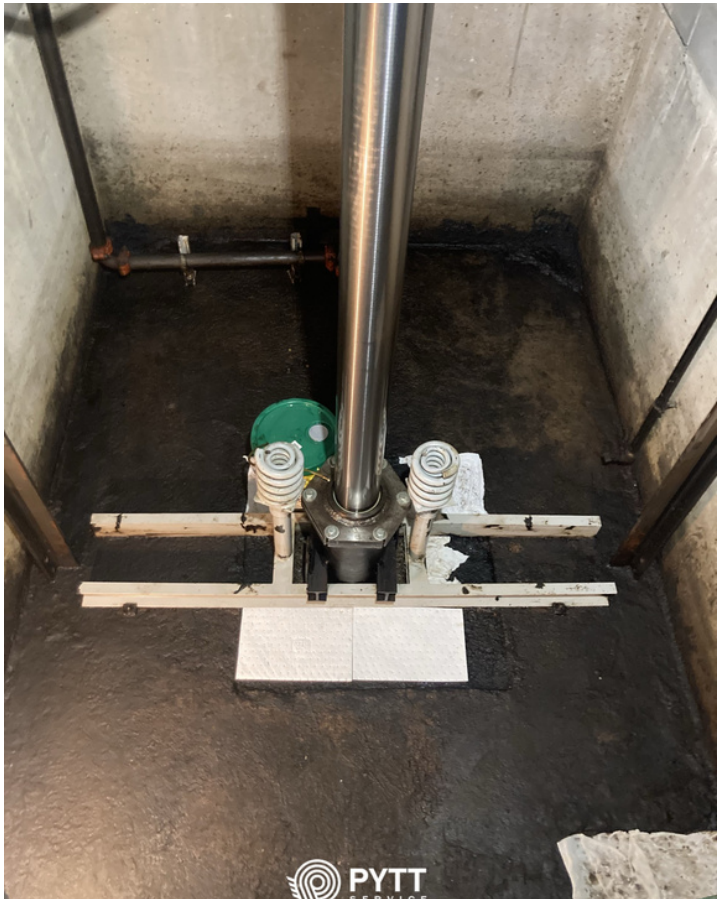
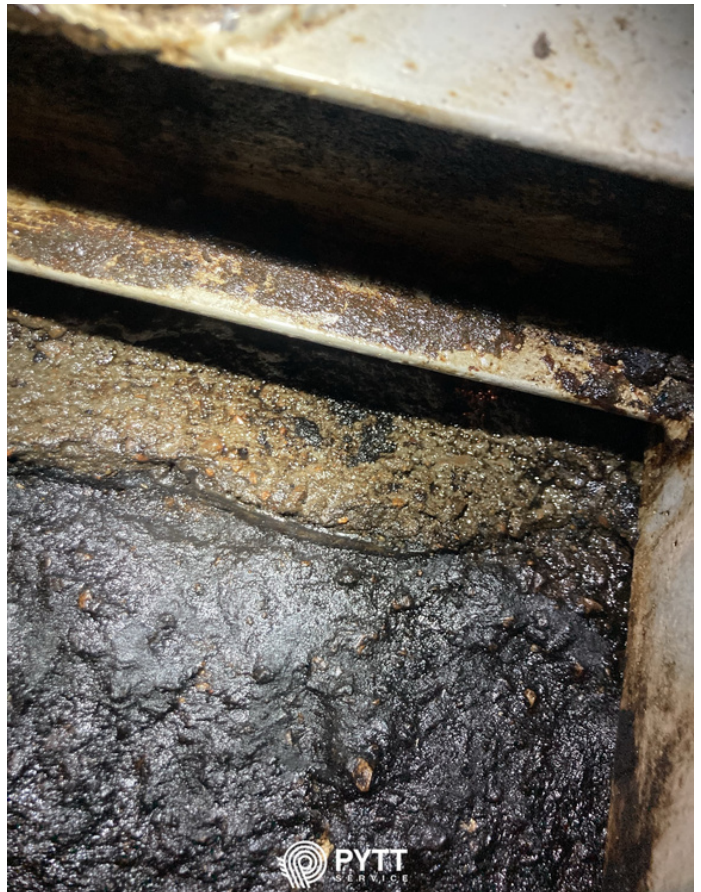
Elevator 1 Oil Pumped Out

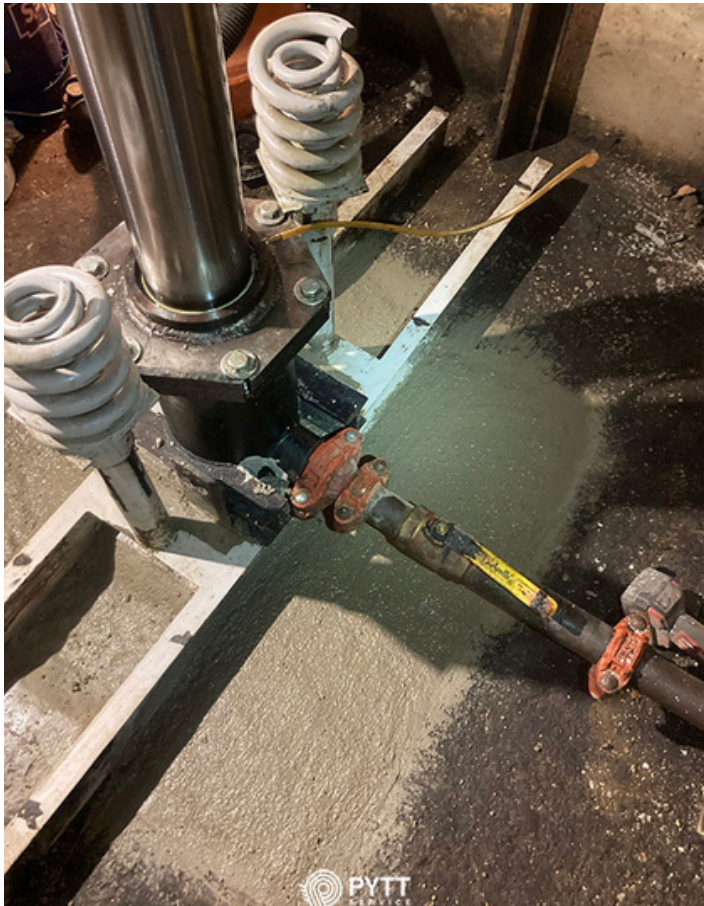
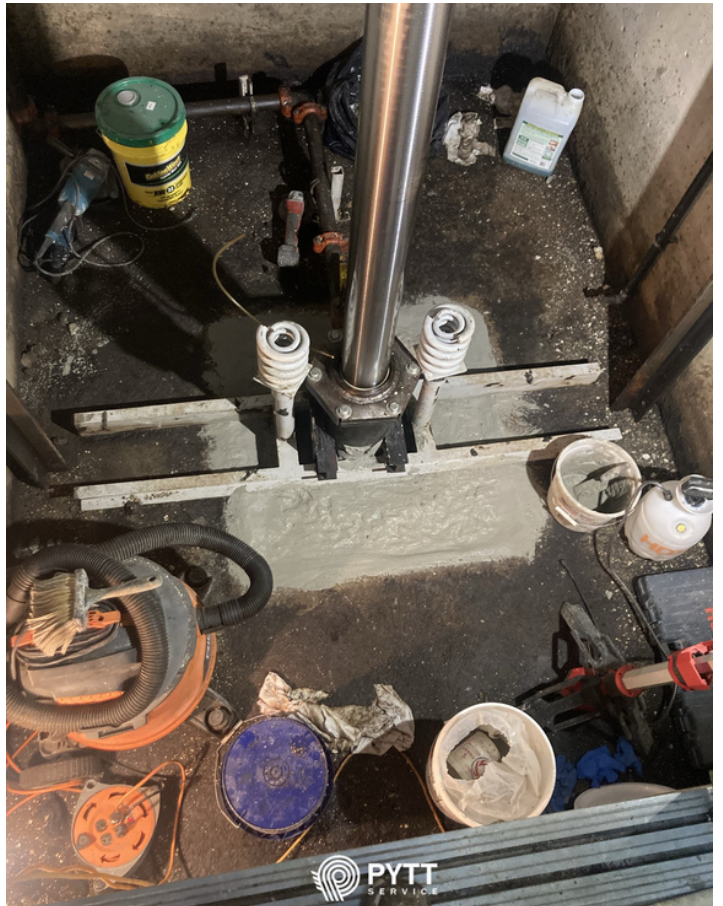
Elevator 1 Jack Cap Replacement, First layer of waterproofing applied

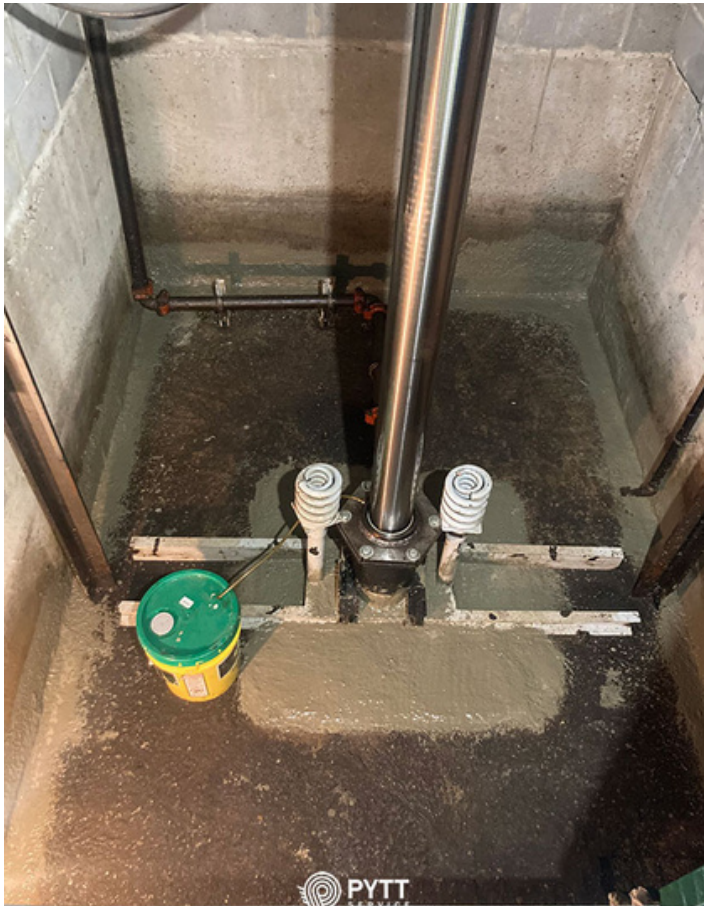
Second layer of waterproofing applied.

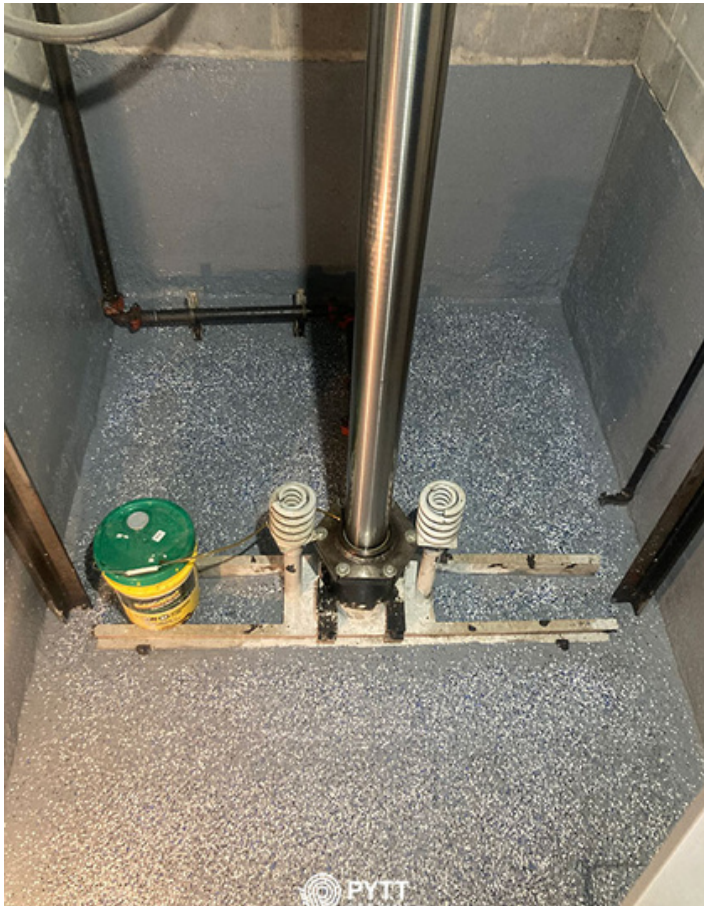
Elevator 1 elevator pit painted and finished
